# **INDOOR AIR QUALITY REASSESSMENT**

**Massachusetts Department of Mental Health  
Site Office Region II  
40 Institute Road  
Grafton, Massachusetts**

Prepared by:  
Massachusetts Department of Public Health  
Bureau of Environmental Health Assessment  
August, 2001

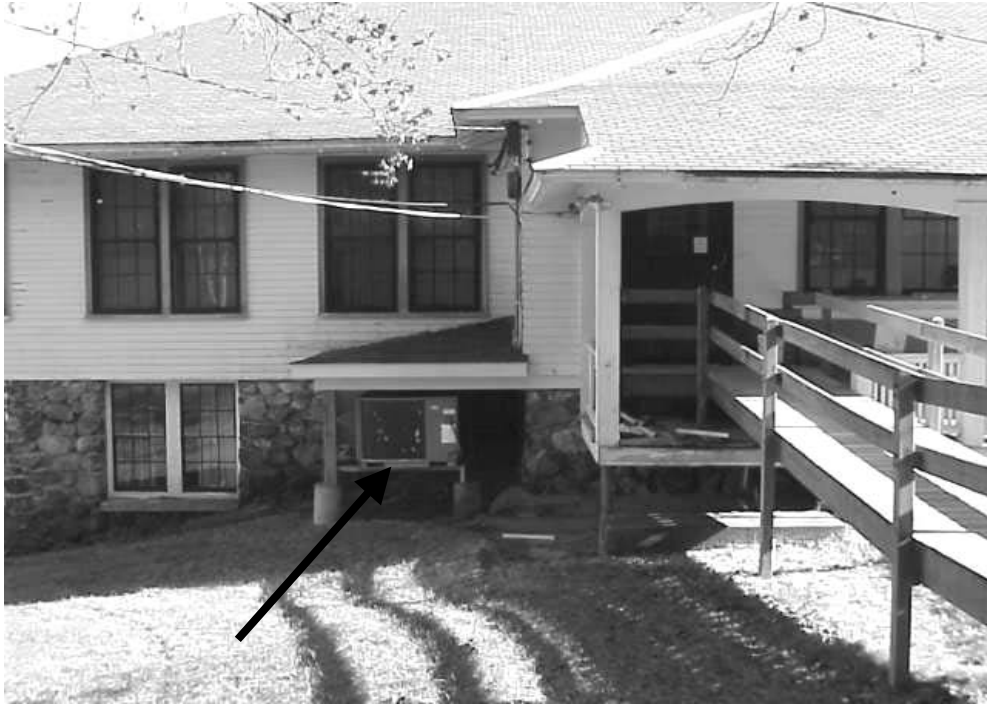
**Picture 1**

level at the front of the building (see Pictures 1 and 2). Suspended ceilings were installed on both floors. The existence of a thick layer of fiberglass insulation on top of the suspended ceiling on the second floor indicates that the renovations were an energy conservation measure.

**Action Taken:** The ventilation system was not operating during this visit. Both air handling units (AHUs) were idle and no airflow was detected from fresh air diffusers.

**AHU Servicing North Zone of Building**

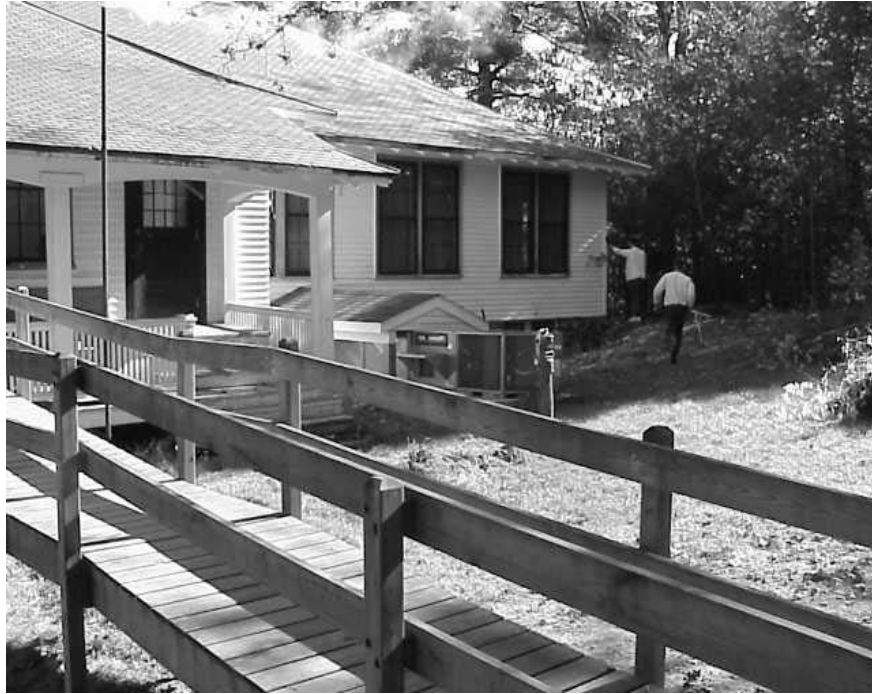
**Picture 2**

**AHU Servicing South Zone Of Building**

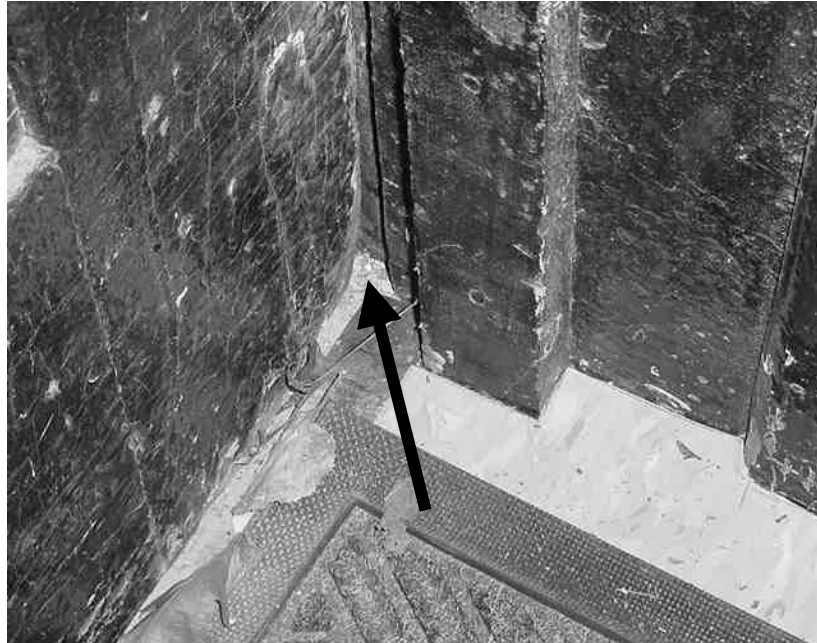
**Picture 3**

**Action Taken:** Exterior doors continue to have spaces wide enough to serve as rodent entryways (see Picture 3). Holes in the rear foundation wall are also wide

**Space Between Exterior Door and Its Doorframe**

- 2. It is highly recommended that the principles of integrated pest management (IPM) be used to rid this building of pests. Holes as small as ¼” provide enough space for rodents to enter an area. Examine each room and the exterior walls of the building for means of rodent egress and seal. If doors do not seal at the bottom, install a weather strip as a barrier to rodents.**

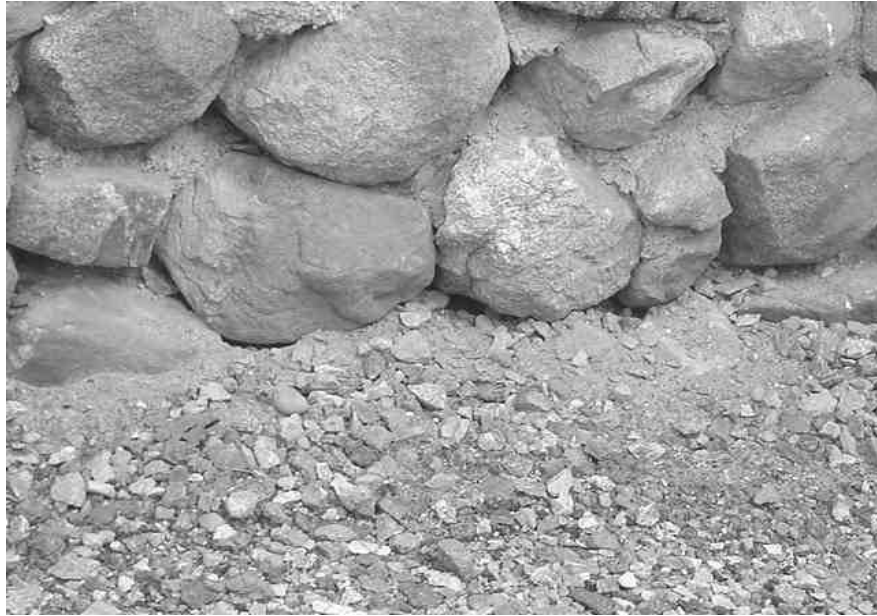
**Picture 4**

enough to admit rodents (see Picture 4). A pipe downhill from the building that protrudes from the hill may also serve as a rodent entryway (see Picture 5).

**Holes In Foundation**

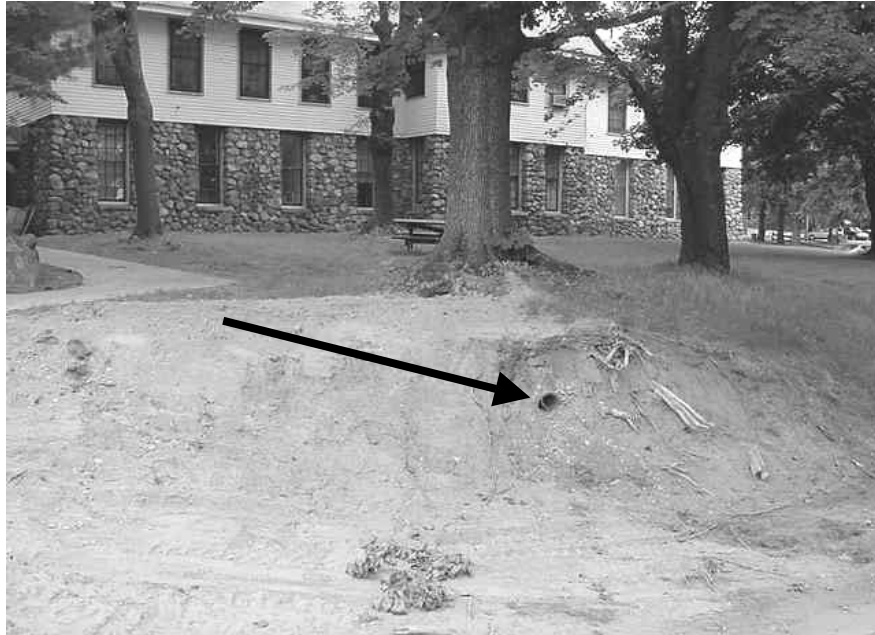
**Picture 5**

**Drain Pipe below MDMH Building**

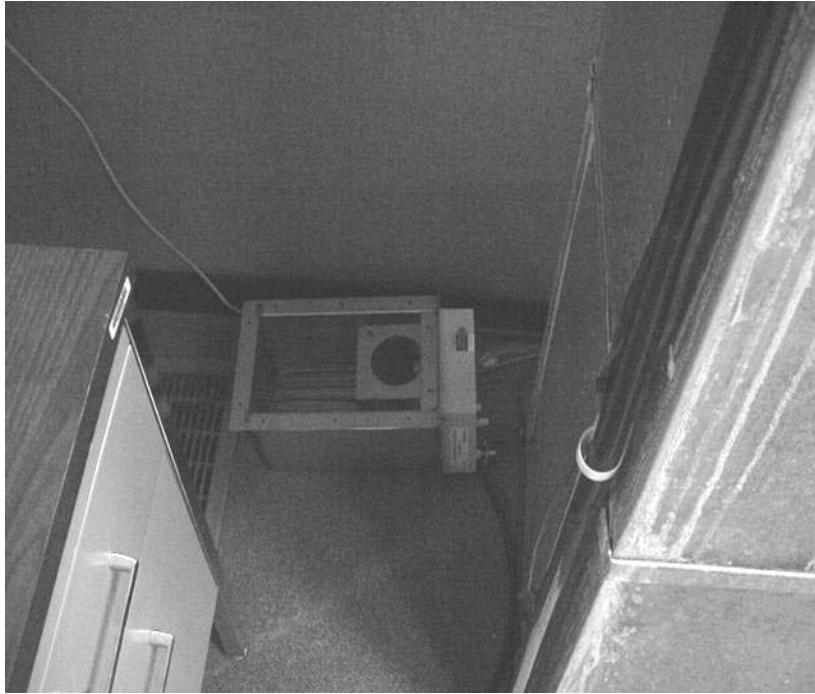
**Picture 6**

**Actions Taken:** The units connected to ducts were humidification units, not condensation drains. The equipment to replace these units was obtained, but not fully installed (see Picture 6). Plastic hoses were not replaced.

The equipment initially identified as condensation pumps are actually a humidification system. Humidification equipment, if not maintained, can be a source of moisture in an HVAC system and a source of microbial growth. According to building staff, the humidification system has not functioned for some time. The interior of the ductwork connected to the humidification system

could not be examined during the assessment. If repairs are not made to the humidification system to restore its function, it is advised to remove the system from the ventilation ductwork. The humidification systems are connected to the drainage system by clear plastic flexible hoses. The interior of these flexible hoses are coated with microbial growth. As the ventilation system operates, negative pressure is created that can draw air from the drain system through these hoses and into the unit. This can be a means for microbial growth and associated odors to be drawn into each unit and distributed by the HVAC system.

**Parts of Humidification System to Be Installed**

1. Fully implement recommendations made in previous reports (MDPH, 2000, MDPH, 2001a and MDPH 2001b), with an emphasis on operating the AHUs with proper filtration. If this cannot be achieved with existing equipment, consider replacing the AHUs with models that can both provide fresh air and exhaust ventilation.
2. Examine the drainpipe shown in Picture 5 and install a screen to prevent rodent ingress. Ensure that maintenance staff checks the screen for clogging weekly or after heavy precipitation to prevent backups.
3. Install screens on rooftop vents to prevent rodent ingress.
4. Consider removing humidification system from ducts. Seal ducts once humidification system is removed.

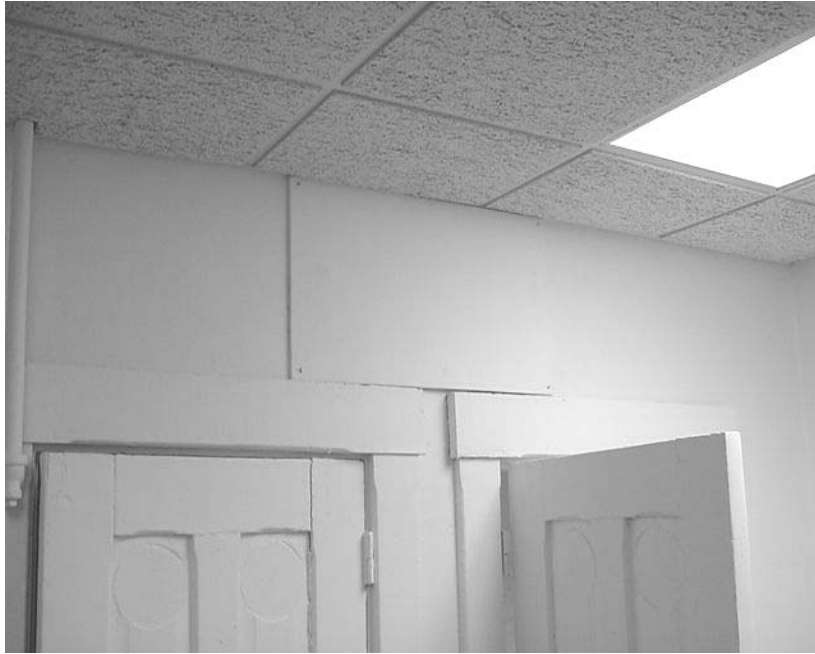
**Picture 7**

**Action Taken:** These heating elements were reportedly disconnected and vents leading to this room were sealed (see Picture 7).

**Sealed Vent outside Mainframe Room**

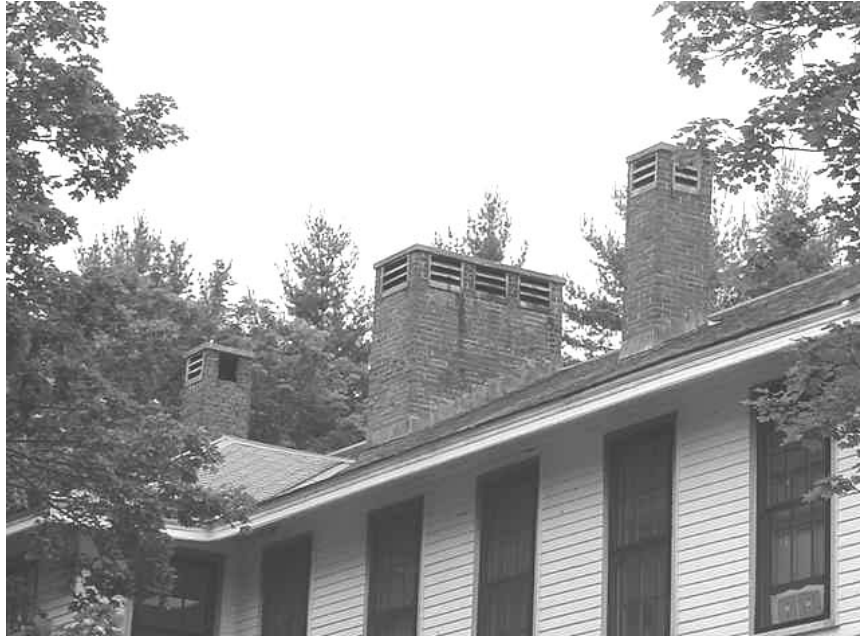
**Picture 8**

Former exhaust ventilation shafts exist on the roof (see Picture 8). The louvers do not appear to have screens to prevent rodents (chipmunks and squirrels) from entering the building. These holes should be equipped with screens to keep rodents from the interior of the building.

**Open Louvers of Rooftop Exhaust Vent**
